Probe Tip

Probe Connector Repair Tool

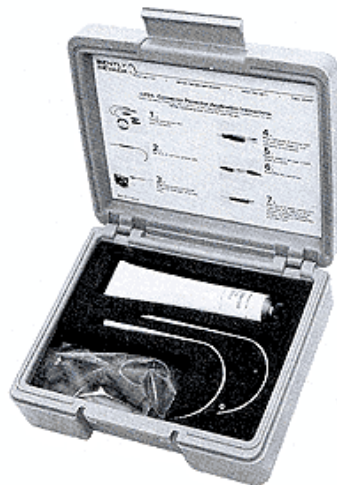
This tool consists of an aluminum cylinder with a knurled grip area containing two precision steel inserts. These inserts are positioned to simulate each of the two mating connectors of our probes and cables. One end of the tool contains a simulated male connector and the other end contains a simulated female connector. This allows you to repair either male or female proximity probe connectors.

Miniature coaxial connectors have stainless steel outer shells that are extremely durable. In contrast, the gold-plated center conductor is less resilient due to its material and the tight tolerances around it. If this conductor is bent off center, the Connector Repair Tool can restore it to its proper position, saving the connector and saving you time and money.

In either situation, the Connector Repair Tool could be used to re-align the conductors and make the connection. The tool can be easily stored in the Connector Protector Kit which is another excellent accessory to have on hand during routine transducer service or maintenance. This kit was recently reduced 25 percent. When you place your next "spare parts" order, request the Connector Repair Tool with the order. The low price of the tool could pay for itself the first time you use it!
